**EOI-457
Morrow Hall Portico Renovation and Other Masonry Repairs
Addendum 1**

RE: ADS File No.: FSU-23-01
Feaster Center Pool Slab Repair
Observation Report

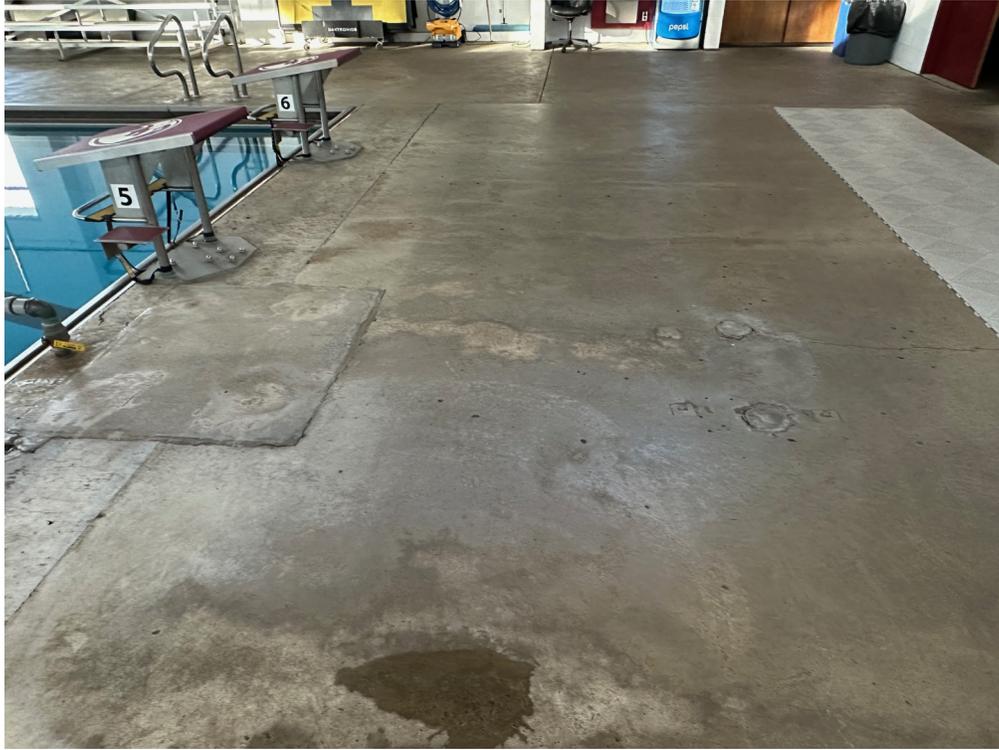
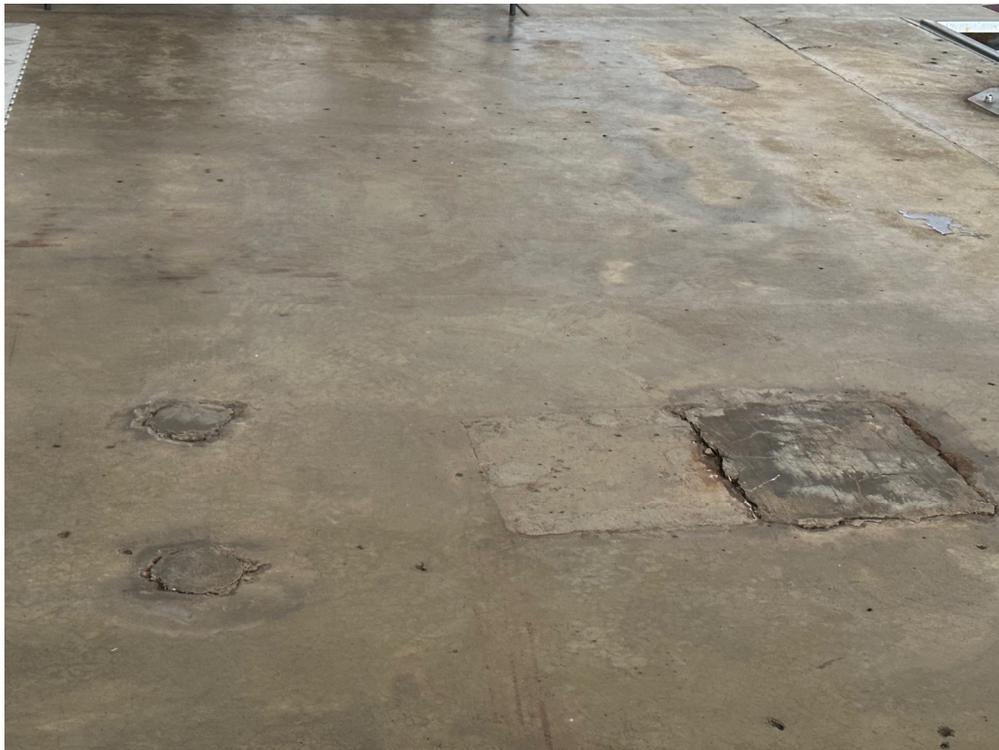
Exhibit A

Cracks were observed in the elevated concrete slab. These cracks are located at or near the former anchorage of the old diving board stands. See Exhibit A. It was also observed from the maintenance room that the bottom of the elevated slab is spalling and deteriorating as well as the steel reinforcing is exposed and rusted. See Exhibit B.

The concrete cracking and spalling along with the deteriorating and rusting of the steel reinforcement in the slab are all caused by exposure to moisture. The slab cracking locations on the top of slab indicate that when the diving board equipment was removed from the site the patched concrete over the diving board anchorage was not properly sealed. This water exposure has spread and is now causing the spalling and reinforcement corrosion in the bottom of the slab.

To resolve this issue the preexisting poorly-patched concrete in the top of the slab should be removed and replaced. Once it is repaired, a protective coating such as an epoxy-based sealant will need to be placed over the repaired sections of concrete. The exposed rusted steel reinforcing in the bottom of the slab should be cleaned free of rust with a grinder. All loose concrete shall also need to be removed from the bottom of the slab. Then non-shrink repair mortar shall be used to patch over the exposed concrete.
