**WEEKLY
REPORT:**

- **LOCUST AVE.
PARKING LOT**
- **RCB GUTTER
REPAIR**
- **CAPERTON
BOILER RE-
PLACEMENT**

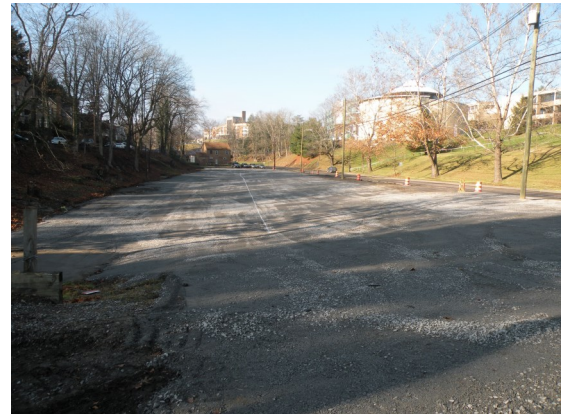
Locust Ave. Parking Lot

The Locust Ave. gravel lot is temporary closed. The parking lot has been re-graded, graveled, and waiting to be striped to assist with parking this spring. This work greatly improved the condition of the parking and will also lend additional parking spaces with a more efficient layout.

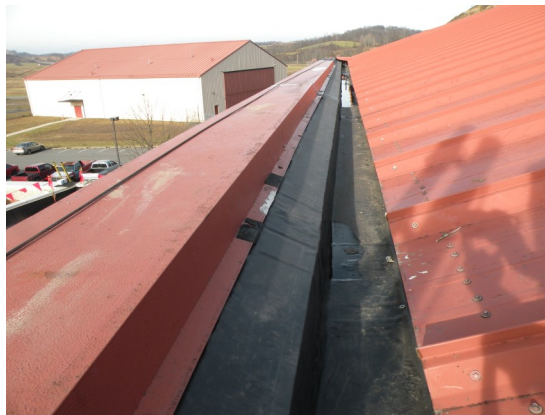
RCB Gutter Repair

Contractor mobilized end of last week. The gutter on the Rotunda side of the Hanger has begun being lined. Each joint in the gutter is being sealed with a 9" lap strip beneath the continuous rubber. The metal coping has been temporarily removed to wrap the rubber up and over the parapet wall to ensure a good seal with minimum penetrations. The drain bodies have been replaced with tubes to ensure no leaks. Overflow drains will be installed for code compliance. Several other small penetrations in the metal roof are also being flashed in while contractor is onsite.
